Long-term impacts of barrier redesign – a case study in York

February 2024

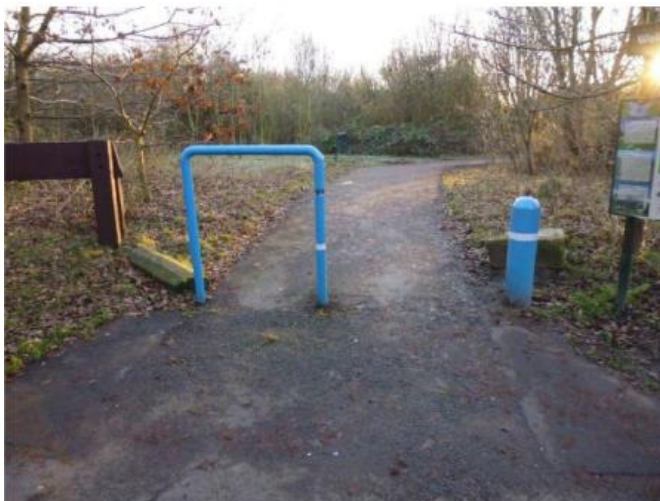
Figure 1 shows one of the redesigned barriers. Changes made include:

- Two small hoops and standalone posts removed.
- Post replaced with 'gas bottle' to create a 1.5m wide gap.
- Stones on either side retained to block bypasses.
- Barriers painted blue and reflective strips added.

Figure 1 - One of the 30 barriers that was redesigned on the Foss Islands path after changes were made. Please note that the barriers after removal do not all meet LTN 1/20 but are still better for a wide range of users than they were before – (c) 2016, Sustrans

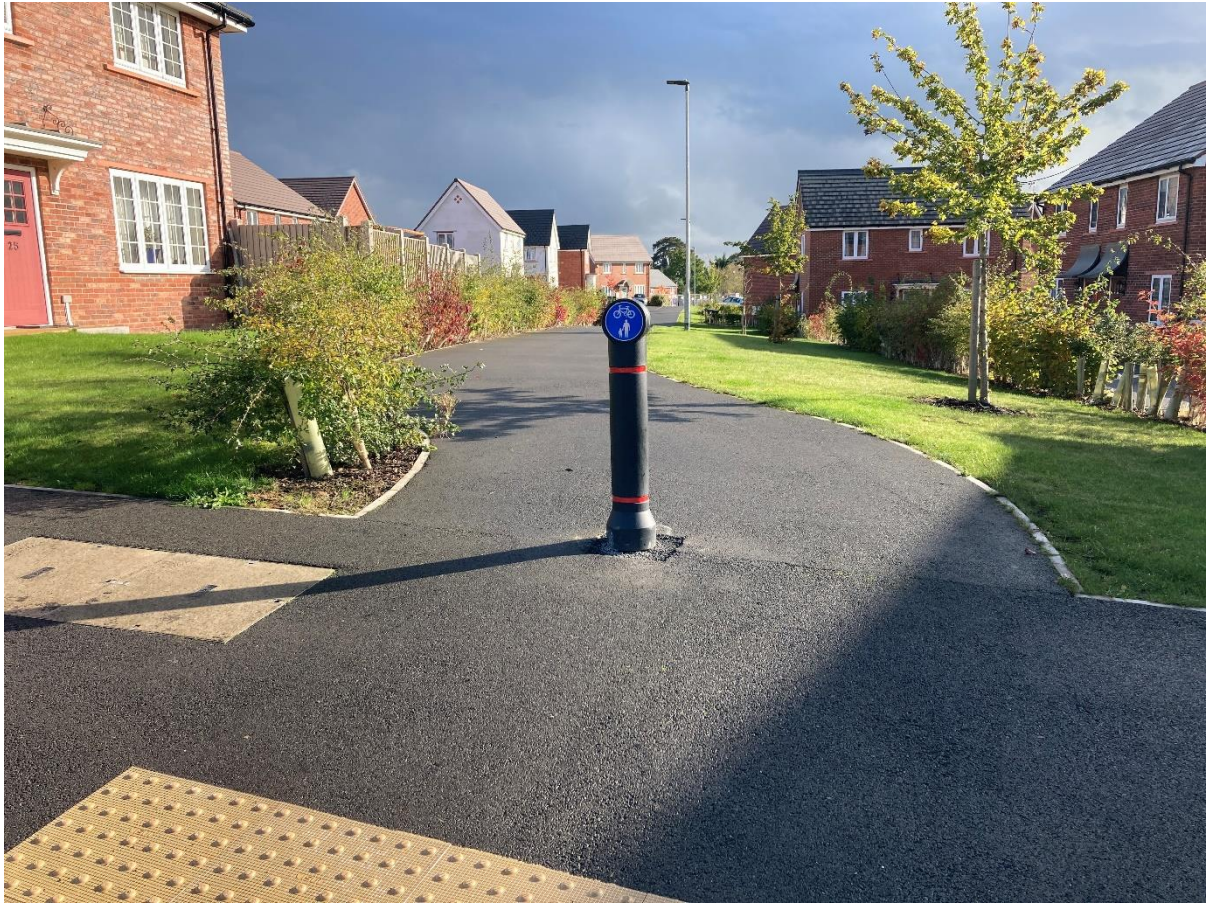
Figure 2 – Dropped kerb and single bollard (with more than 1.5m spacing either side) at entrance to shared use path.

The Welsh Government says that barriers should not be used to slow cyclists and instead recommends arrangements like shown in Figure 2, where clear sight lines and bollards with a minimum spacing of 1.5m can prevent motor vehicle access, whilst retaining better permeability for users than chicane barriers. In Wales, a minimum width of 1.5m is required between bollards on cycle paths to accommodate the full range of cycles and gates should not be used¹⁷.

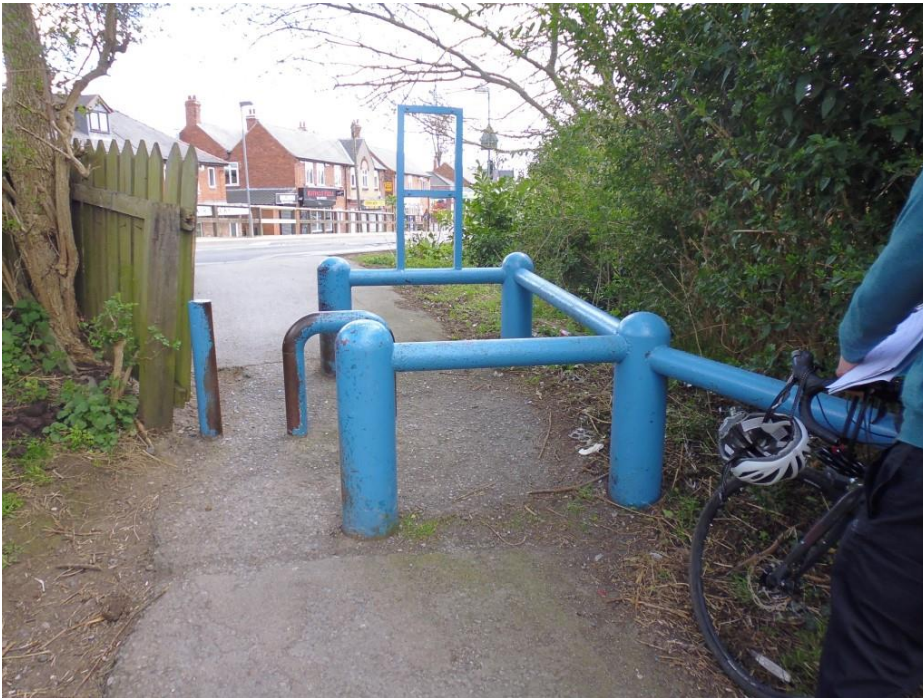
Figure 4 – A barrier on the Foss Islands path before changes were made (c) 2016 Sustrans

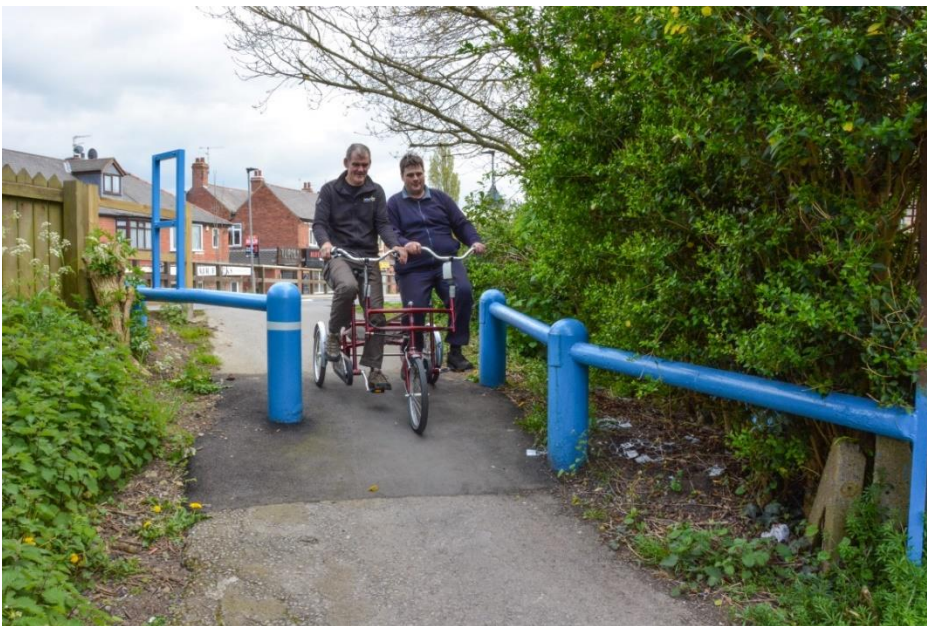
Figure 5 - The same access point on the Foss Islands path after changes were made. Please note that this does not meet LTN 1/20 but are still better for a wide range of users than they were before. (c) 2017 Peter Cox, all rights reserved

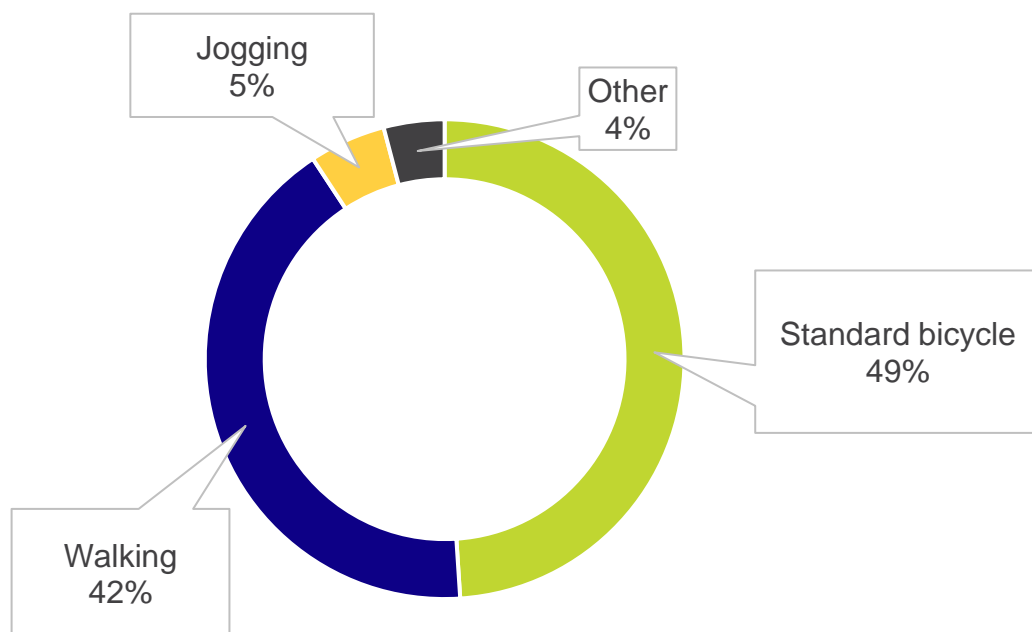
Figure 6 - Modes used on path (both sites combined)

Most trips were either people using a standard bike (49%), walking (42%) or jogging (5%). The remaining 4% includes a range of modes as detailed in Figure 7.

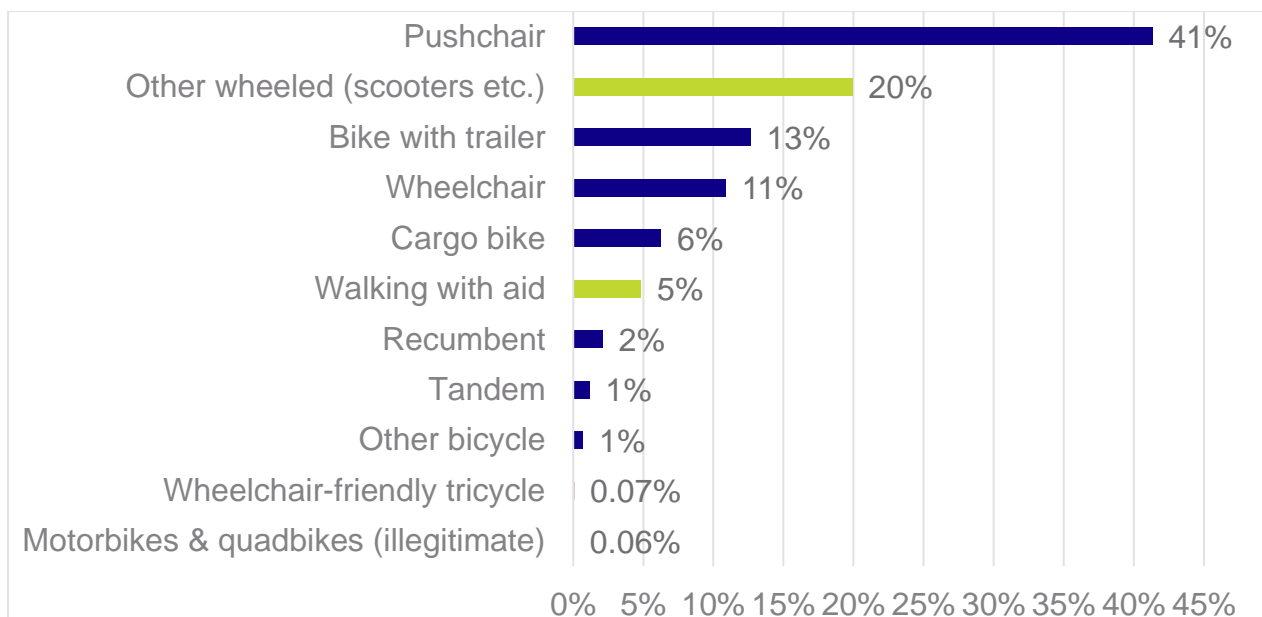
Figure 7 - Breakdown of 'other' modes

At site 1 and 2, there were an average of 37 and 53 trips counted daily with people using modes that may have been prevented from accessing the path prior to the barrier changes. This includes people using pushchairs, bicycles with trailers, wheelchairs, cargo bikes, recumbents, tandems, other bicycles and wheelchair-friendly tricycles.
