Access Control Removal Research

Sustrans Innovation Fund Report

November 2016

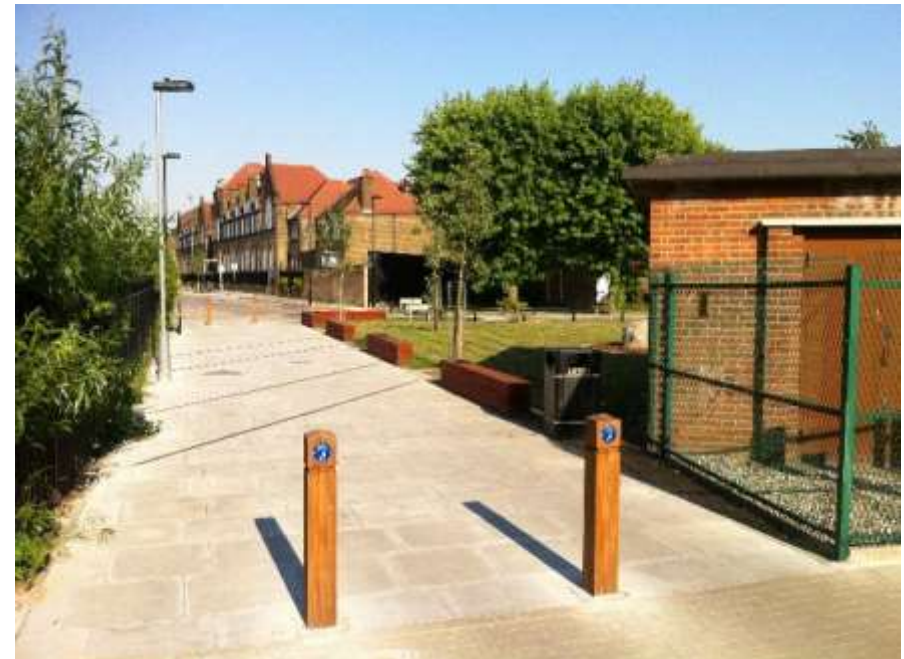
Image: A typical access control in Haringey, North London

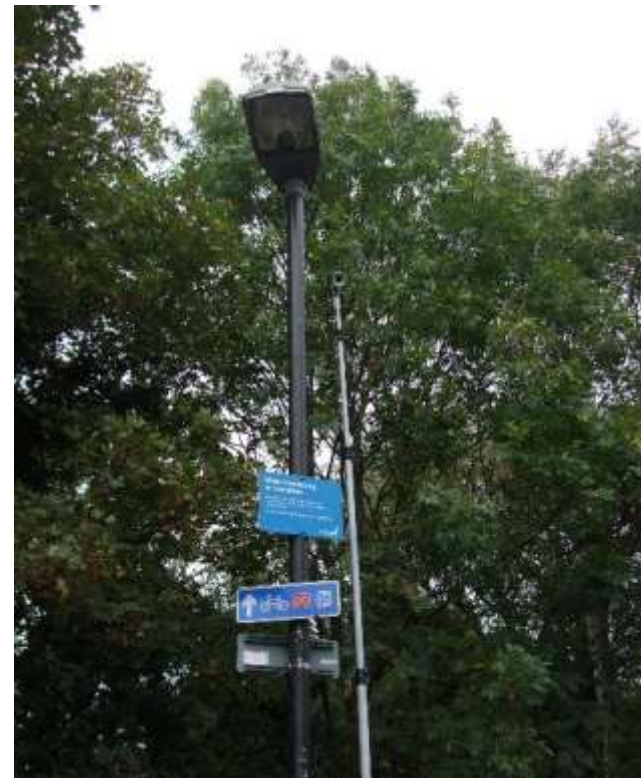
Image: Video monitoring equipment at Site Two

- A camera was installed to capture user types, behaviour and counts pre/ post removal. At each site data was collected from 7am to 8pm each day for the monitoring period
- A questionnaire to collect opinion from cyclists and pedestrians using each space. Across both sites 70 users were surveyed (29 cyclists, 28 pedestrians, 13 stated they walked and cycled).
- Door to door surveys with houses in close proximity to each intervention to understand change in the local environment as a result of barrier removal. Combined with user intercept surveys, 41 people living in close proximity to barriers were surveyed across both sites.
- A site visit with disabled cyclists from Wheels for Wellbeing during the pre and post removal stages to understand the impact of the original barriers and to document changes. During this visit, a range of bikes were used to capture the user experience.

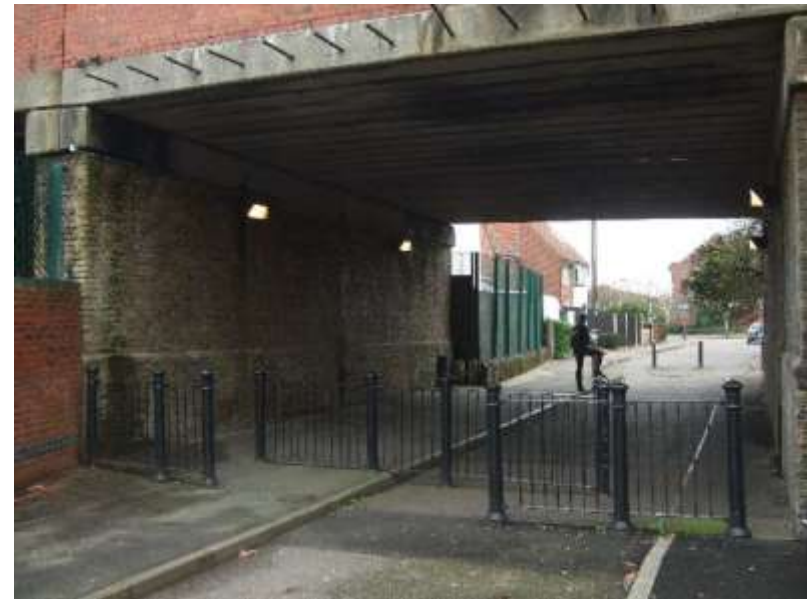
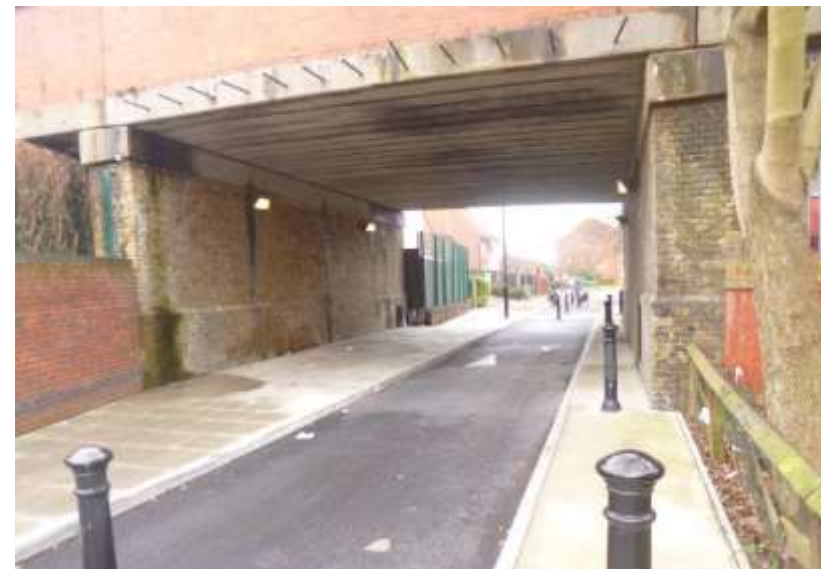
Images: Stevenson Crescent before (above) and after (below)

The original layout consisted of two barriers at the entries to the underpass, each formed of staggered railings across the width of the street (photo above right). A one metre gap was provided between railings to enable access.

Due to spacing, cyclists were required to stop and dismount to negotiate the barriers, while pedestrians were required to leave the footpath and enter the cycle route. Previous consultation with local residents suggested a long term problem with P2Ws using this route as a cut through, as well as anti-social behaviour.

In January 2015, the barriers were removed and replaced with a layout that included bollards to prevent cars from entering the site, upgrade of the footway and carriageway to provide dedicated cycling and walking facilities, and urban realm improvements such as greening and lighting.

Motorcycle speed humps were also introduced at the site, with the aim of deterring use by P2Ws at the site, while still allowing access by cyclists.

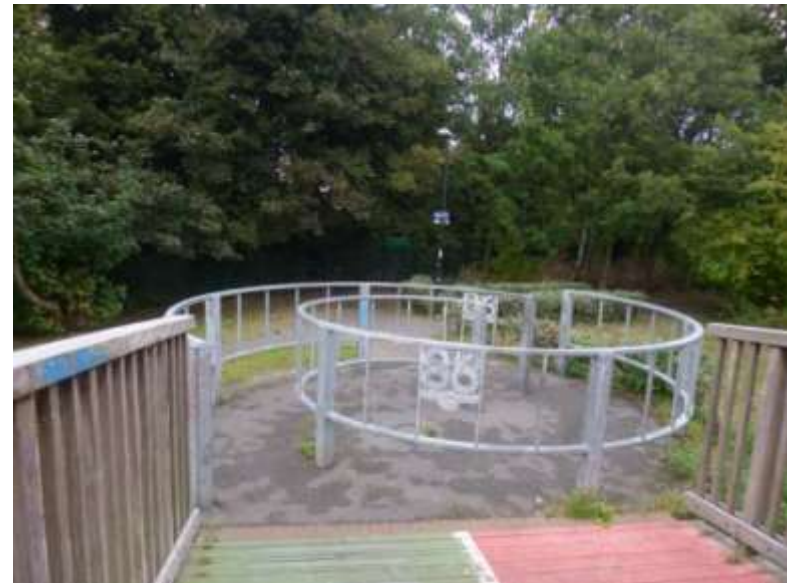
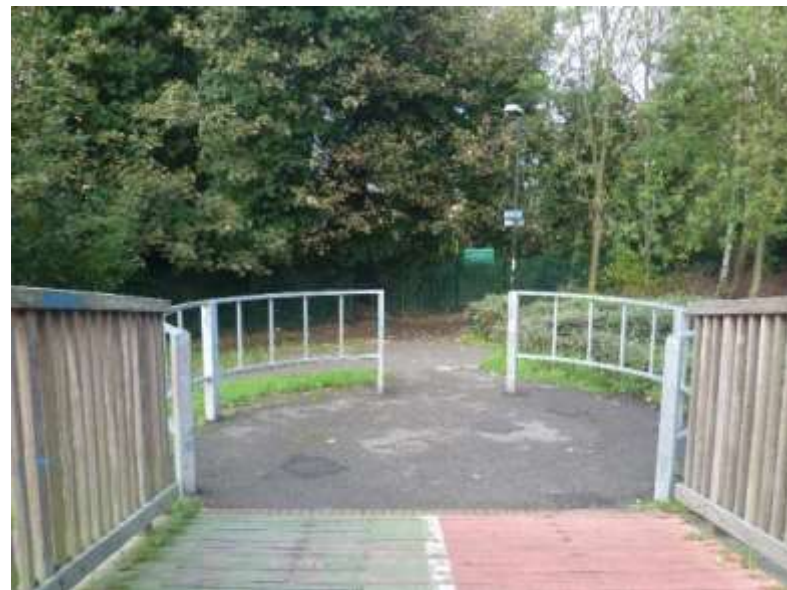
Images: Watercress Park before (above) and after (below)

The original barrier was installed by Sustrans in 2003, and was intended as a piece of artwork combined with a P2W deterrent. This was subsequently adapted by the borough. However, until removal it formed a significant barrier to cyclists, wheelchair users, and pushchair users, due to the necessity to negotiate a curved pathway, which is 1m in diameter (see picture below).

In November 2014 the barrier was adapted to enable access for a wider range of users. This involved removal of the chicane feature, and retention of a proportion of railing to create a 1.5 metre entrance to the route. Railing was retained to slow cyclists exiting the connecting bridge, and to form a barrier between the path and the river.

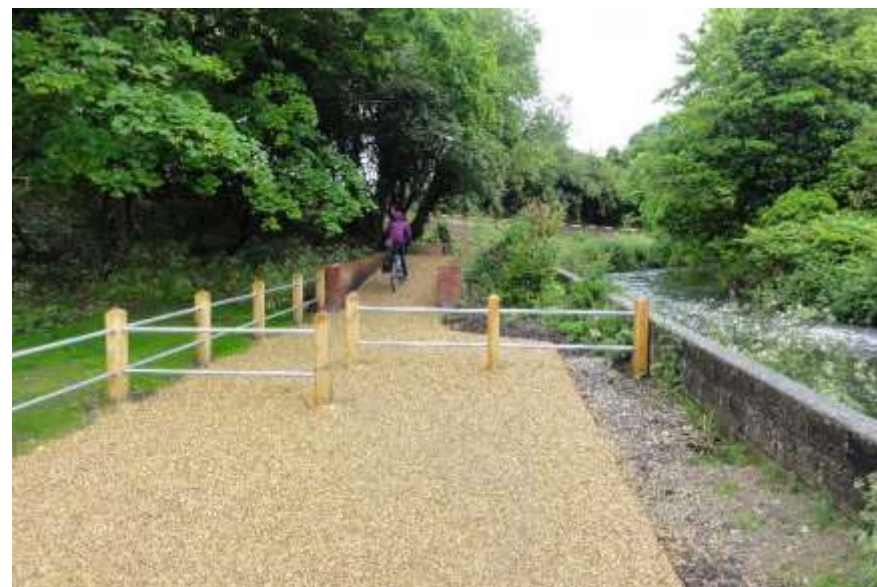
Image: Wide access controls at the Wandle Trail enable conflict free journeys for cyclists and pedestrians along a traffic-free greenway

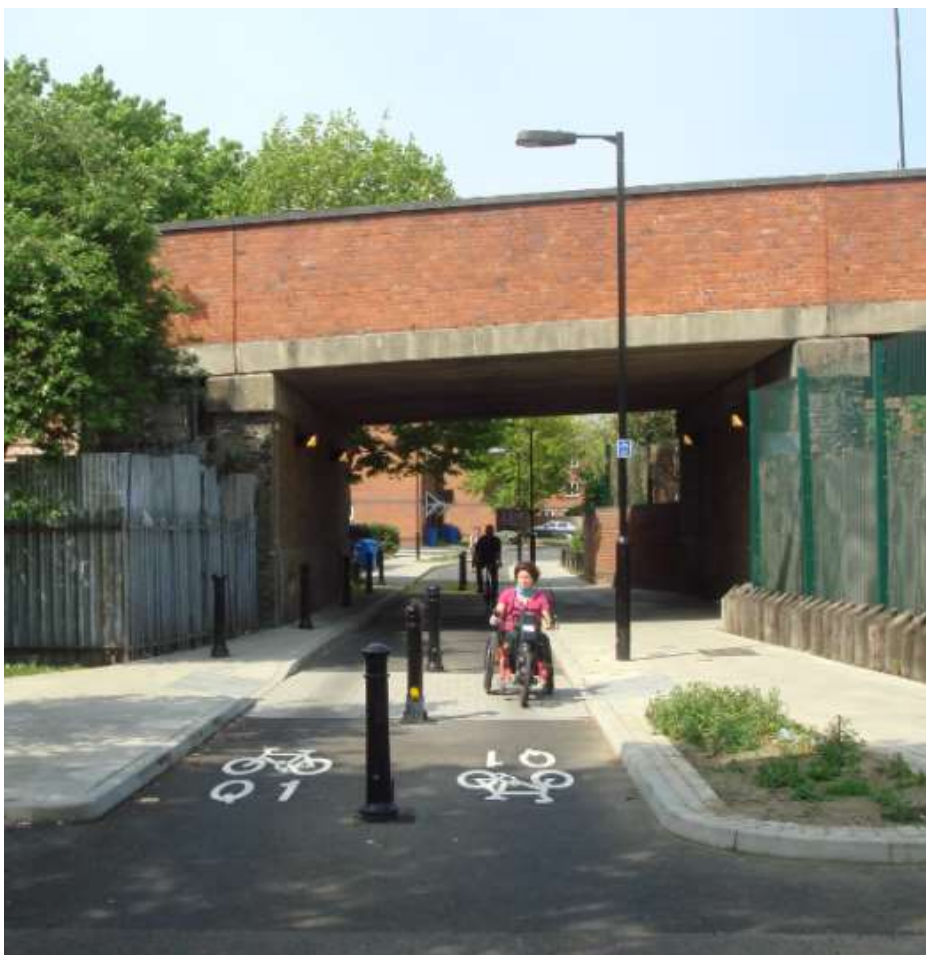
Image: Handcycle user accessing route through Stevensons Crescent, (Site One), where access was previously restricted

- 3 people using mobility aids were recorded using Site One after removal of the barrier. Before removal none were recorded
- A 51% increase in pushchair users was documented at Site One
- Two disabled users interviewed stated that they were more encouraged to use the space, and travelled through more frequently as a result
- 100% of respondents stated that they felt changes increased accessibility for all users

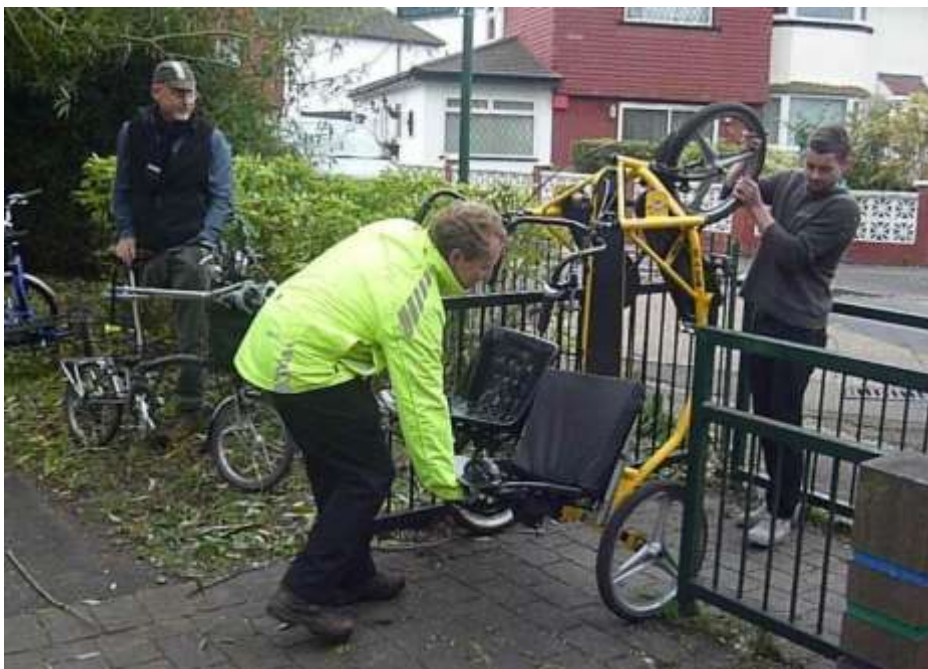
Image: Users attempting to negotiate typical barrier with two person trike

When tested on more conventional access barriers, these also had a significant impact on journeys. As shown in the photos below, it was necessary for users to dismount to negotiate the side by side trike (a movement many disabled users will not be able to make), while it was not possible to cycle the trike through narrow staggered barriers.

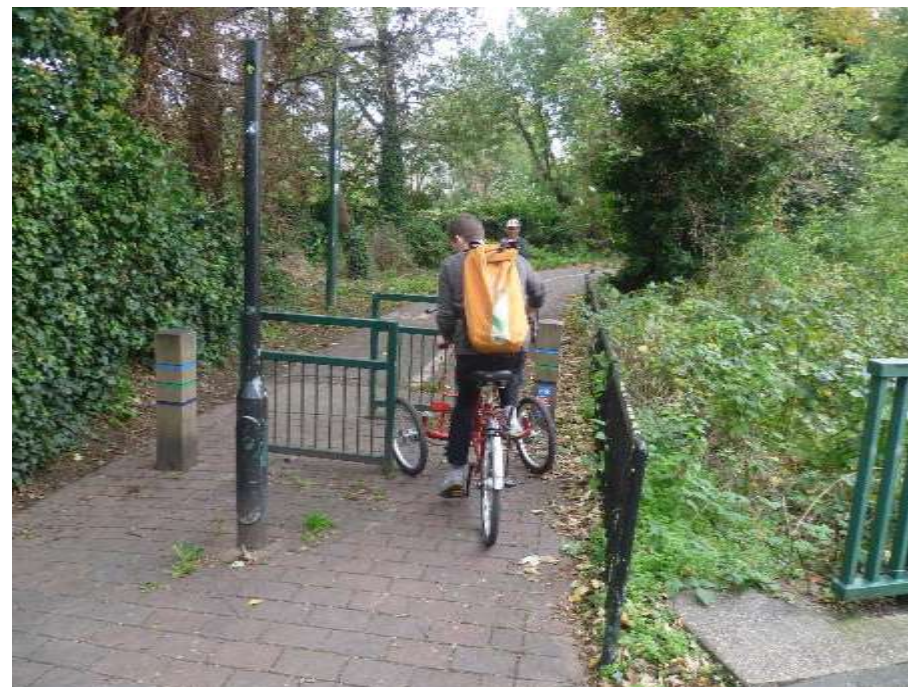
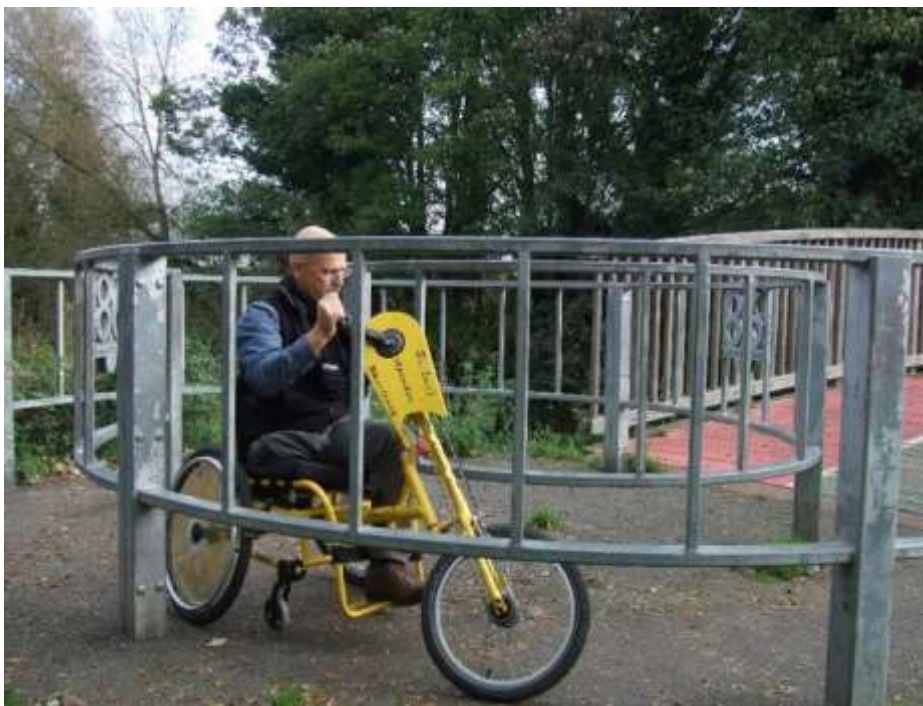
Images: Adapted cyclists attempting to negotiate barriers installed along the Wandle Trail route (Site Two)

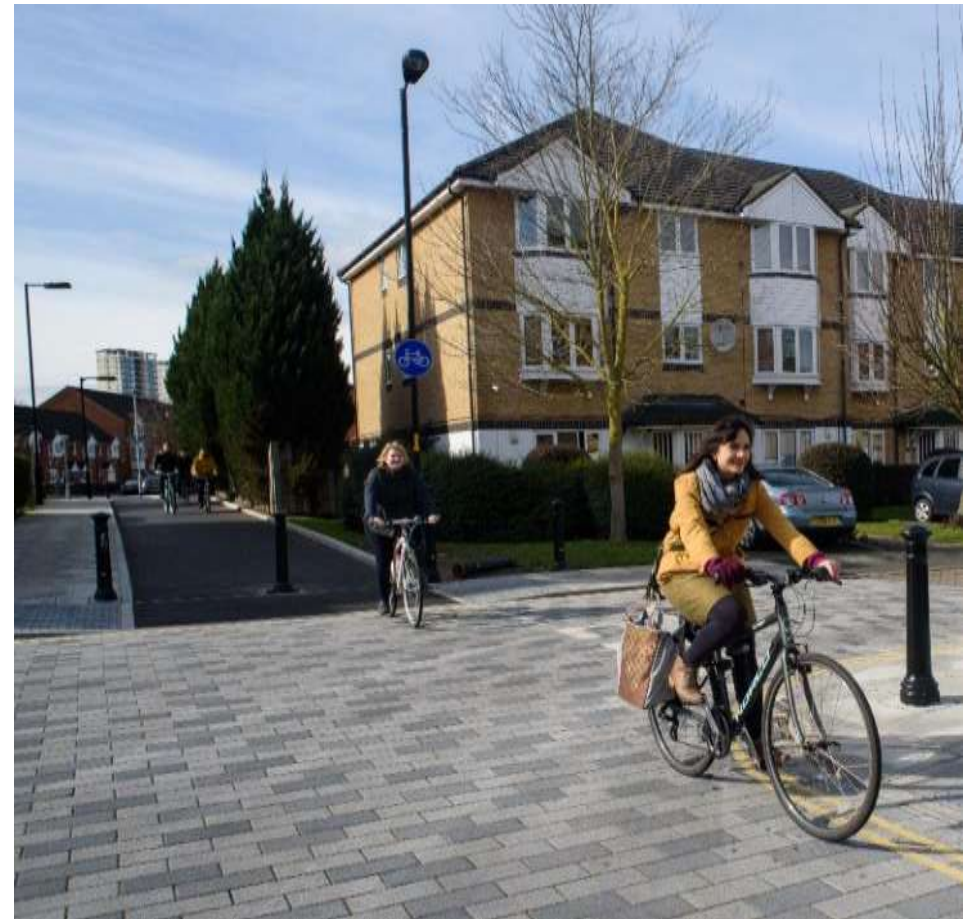
Image: The new barrier free route through Stevensons Crescent (Site One) has increased footfall through this residential area, increasing perception of space and reducing fear of crime and anti-social behaviour

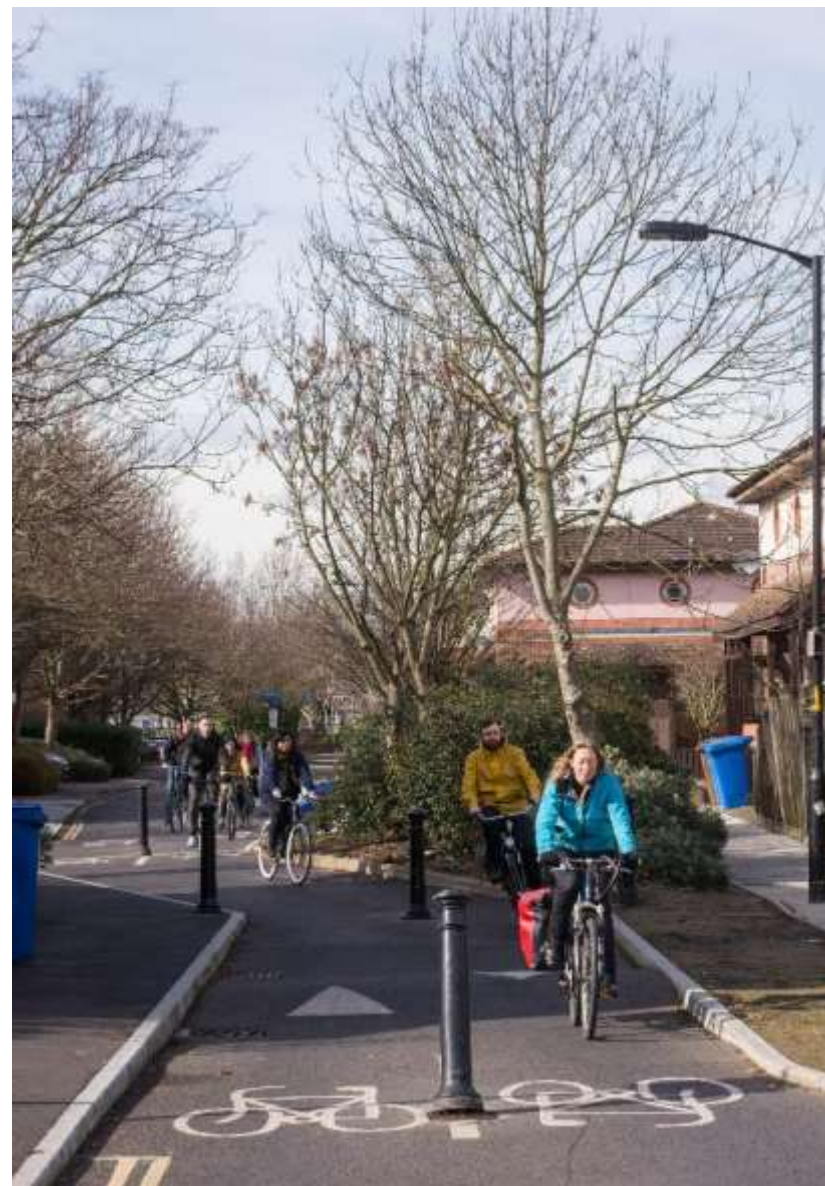
Image: Use of bollards across Quietway One prevent vehicle access, while improving access for communities, pedestrians and cyclists

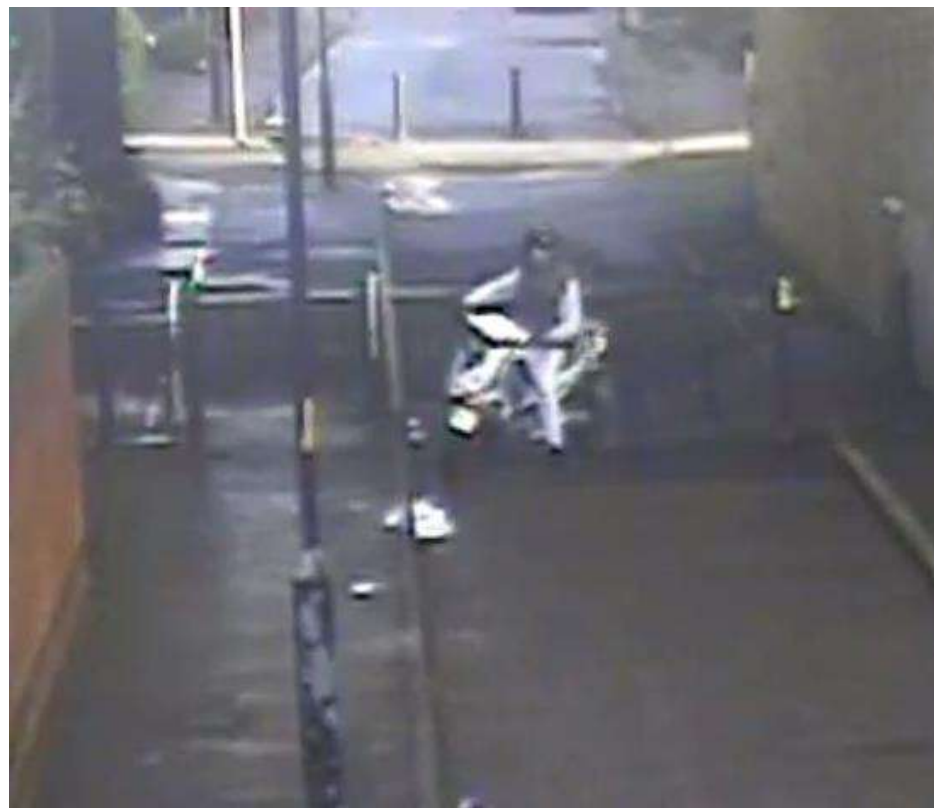
Image: A moped user negotiating the Stevensons Crescent barrier before removal of the barrier
